Beech Hill Pond Watershed Survey 2010

February 2011

**Hancock County Soil & Water
Conservation District**

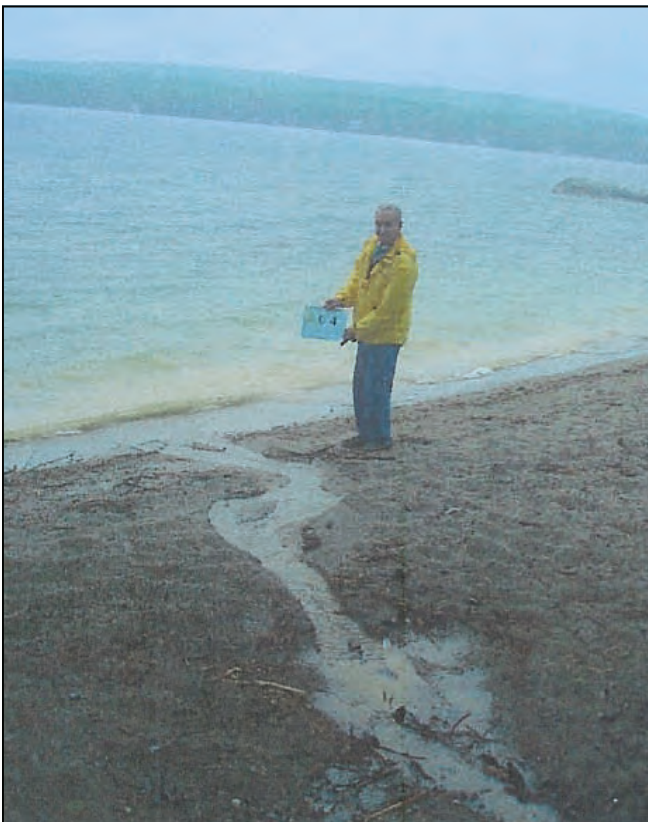
An eroded channel going directly into Beech Hill Pond.

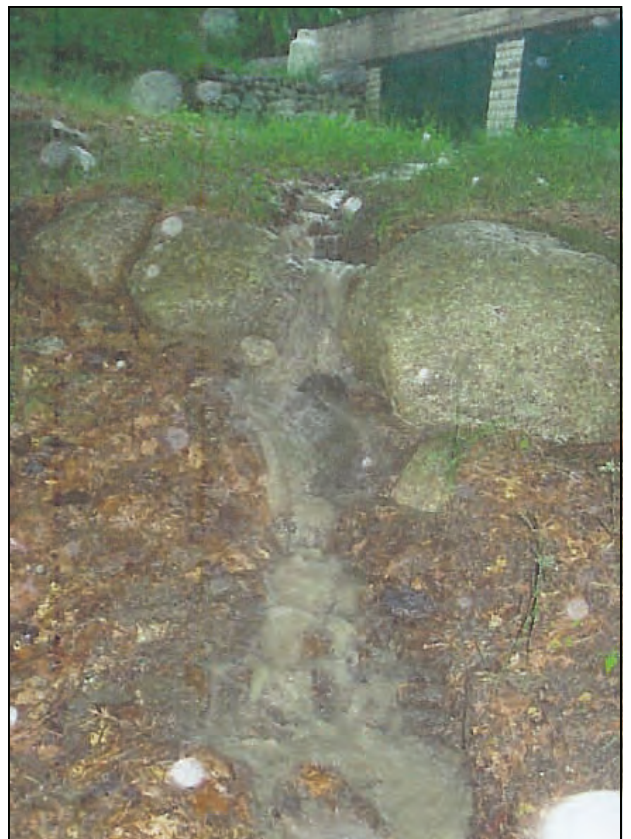
Dirty water during a rainstorm running over a bank into the lake.

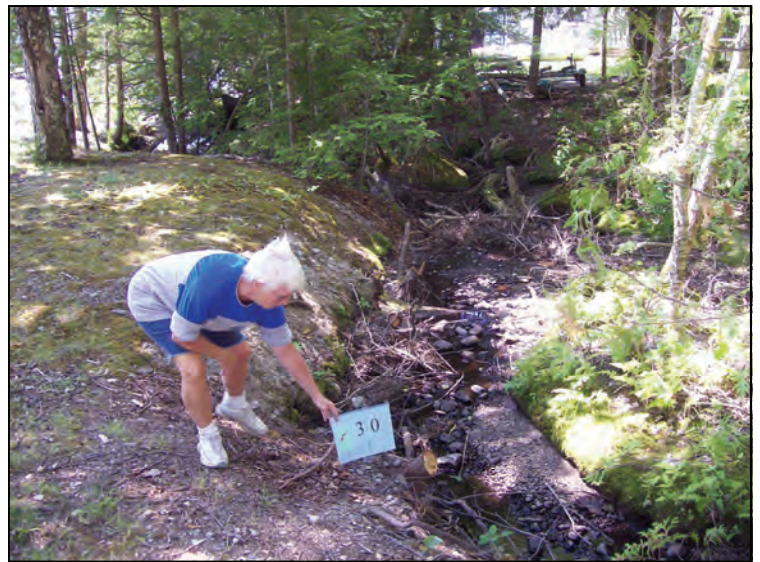
An eroding stream channel full of gravel.

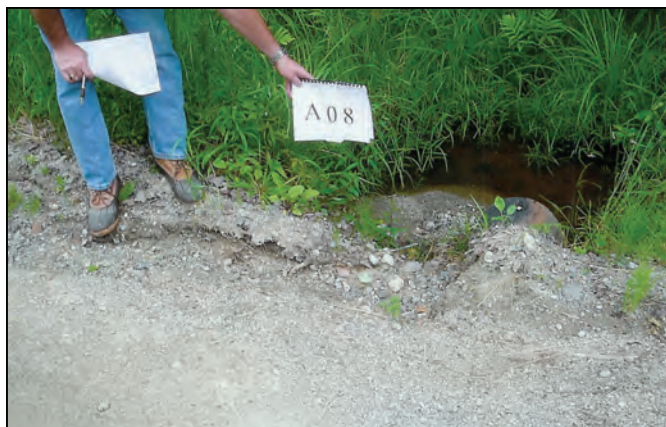
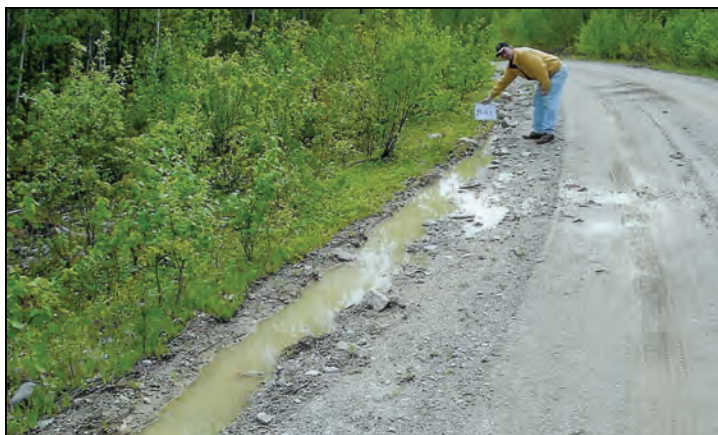
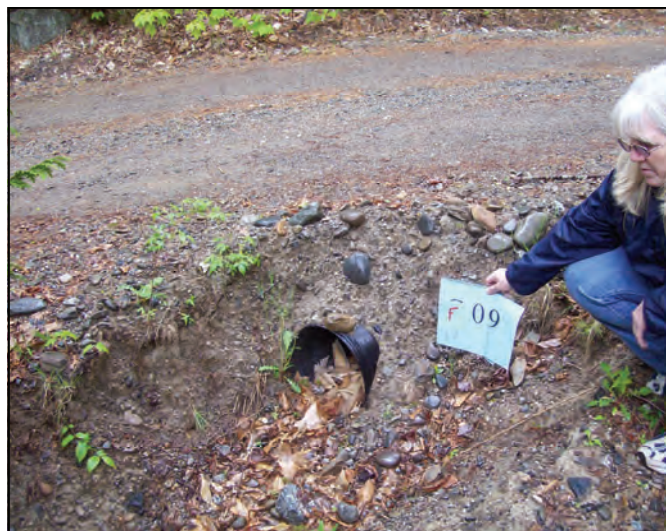
- Unstable culverts (inadequate size, not functioning, unstable inlets and outlets)
- Ditch and shoulder erosion
- Grader berms left behind from plowing or grading that prevent water from flowing off the road
- Surface erosion

- Install new culverts and stabilize the ends with stone
- Clean, reshape, and armour ditches with angular stone or vegetation
- Remove grader berms
- Crown and reshape roads to allow for proper drainage

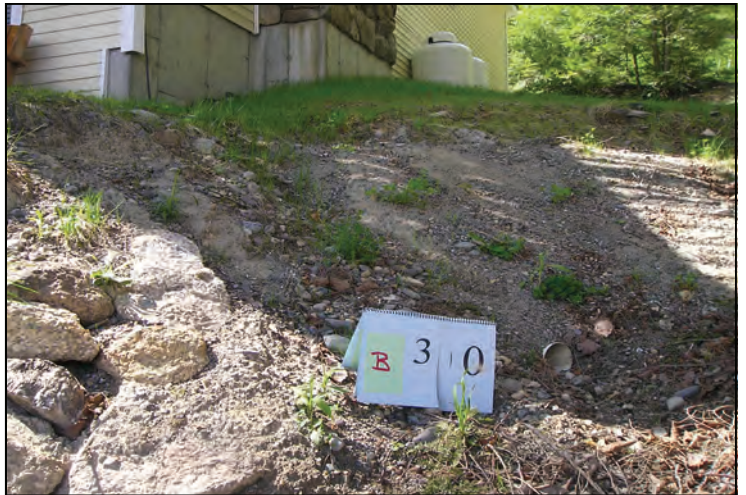
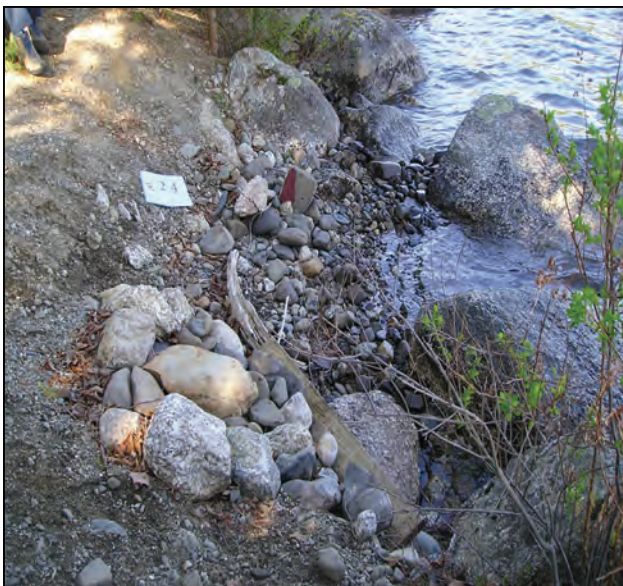
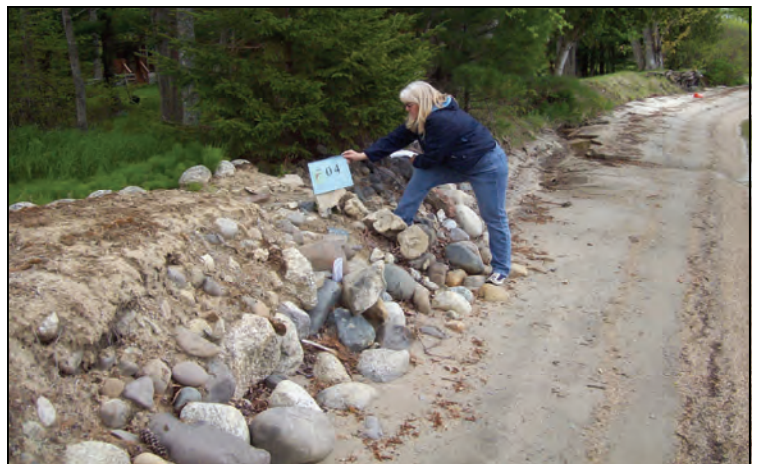
- Inadequate or lack of shoreline buffers (94 of the 115 residential sites)
- Surface erosion or bare/open soil areas
- Driveway erosion issues
- Uncovered soil piles

- Install vegetated buffers
- Crown driveways
- Vegetate or mulch open areas
- Cover soil piles with tarps or remove piles
